RHIC Retreat 2006

J. Sandberg

July 2006

2. Response to 1006 Arc Flash

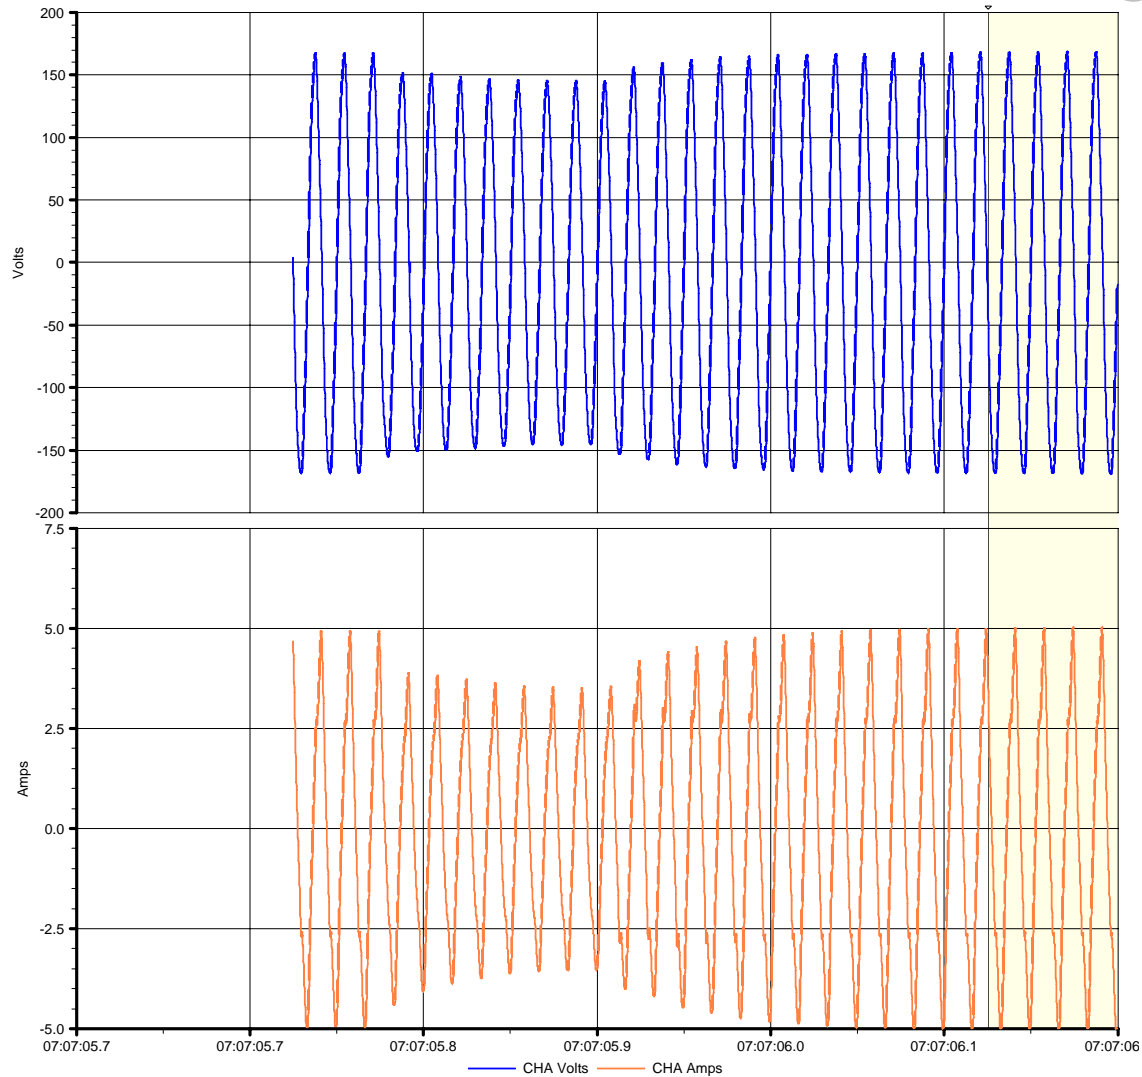
1005H PP1 CKT 14

17 % dip
10 cycles

Waveforms at 04/14/2006 07:07:06

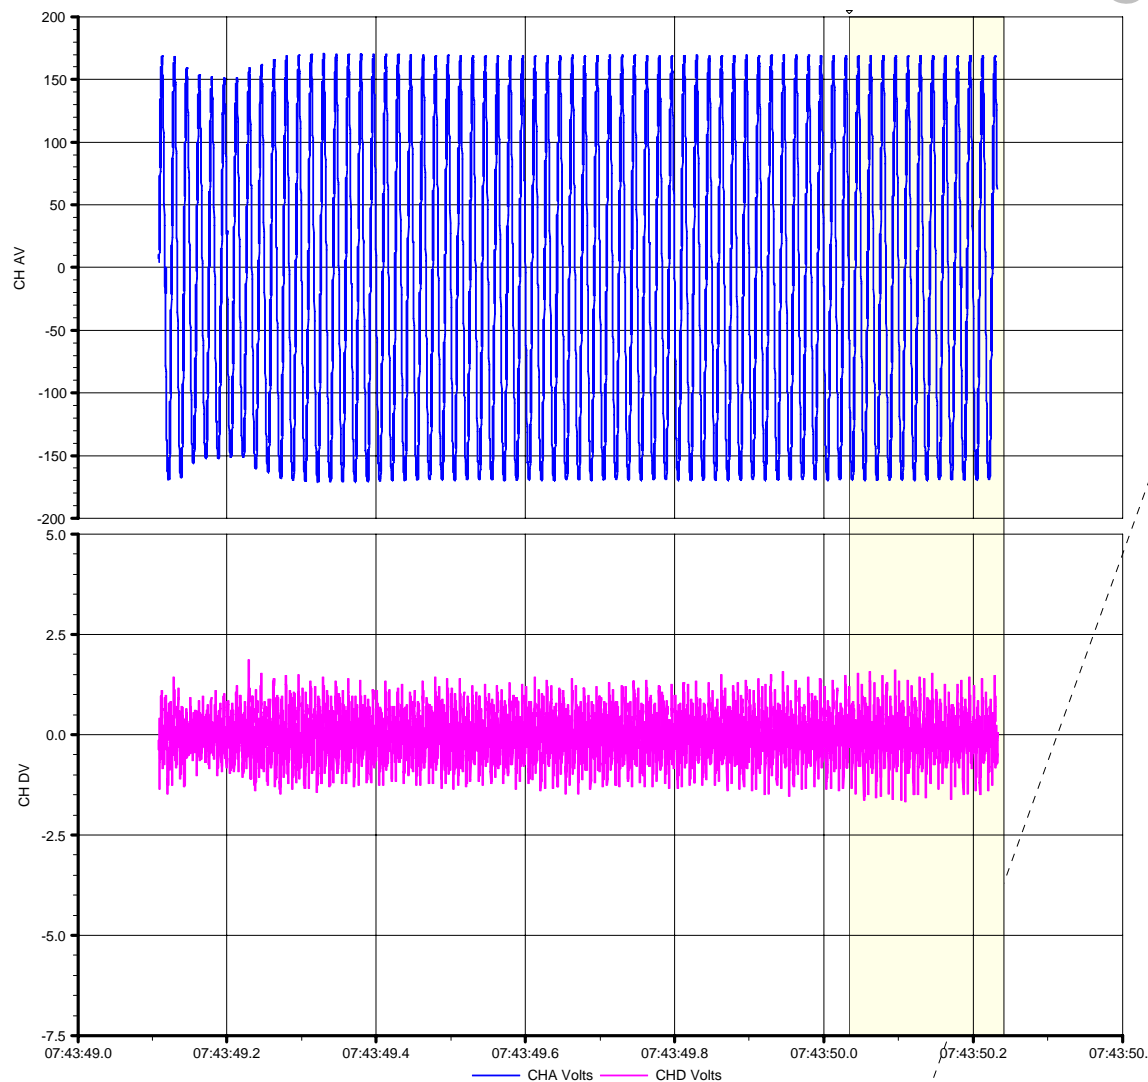
1005H PP1 CKT 14

11.7 % dip
9 cycles

Waveforms at 06/10/2006 07:43:50

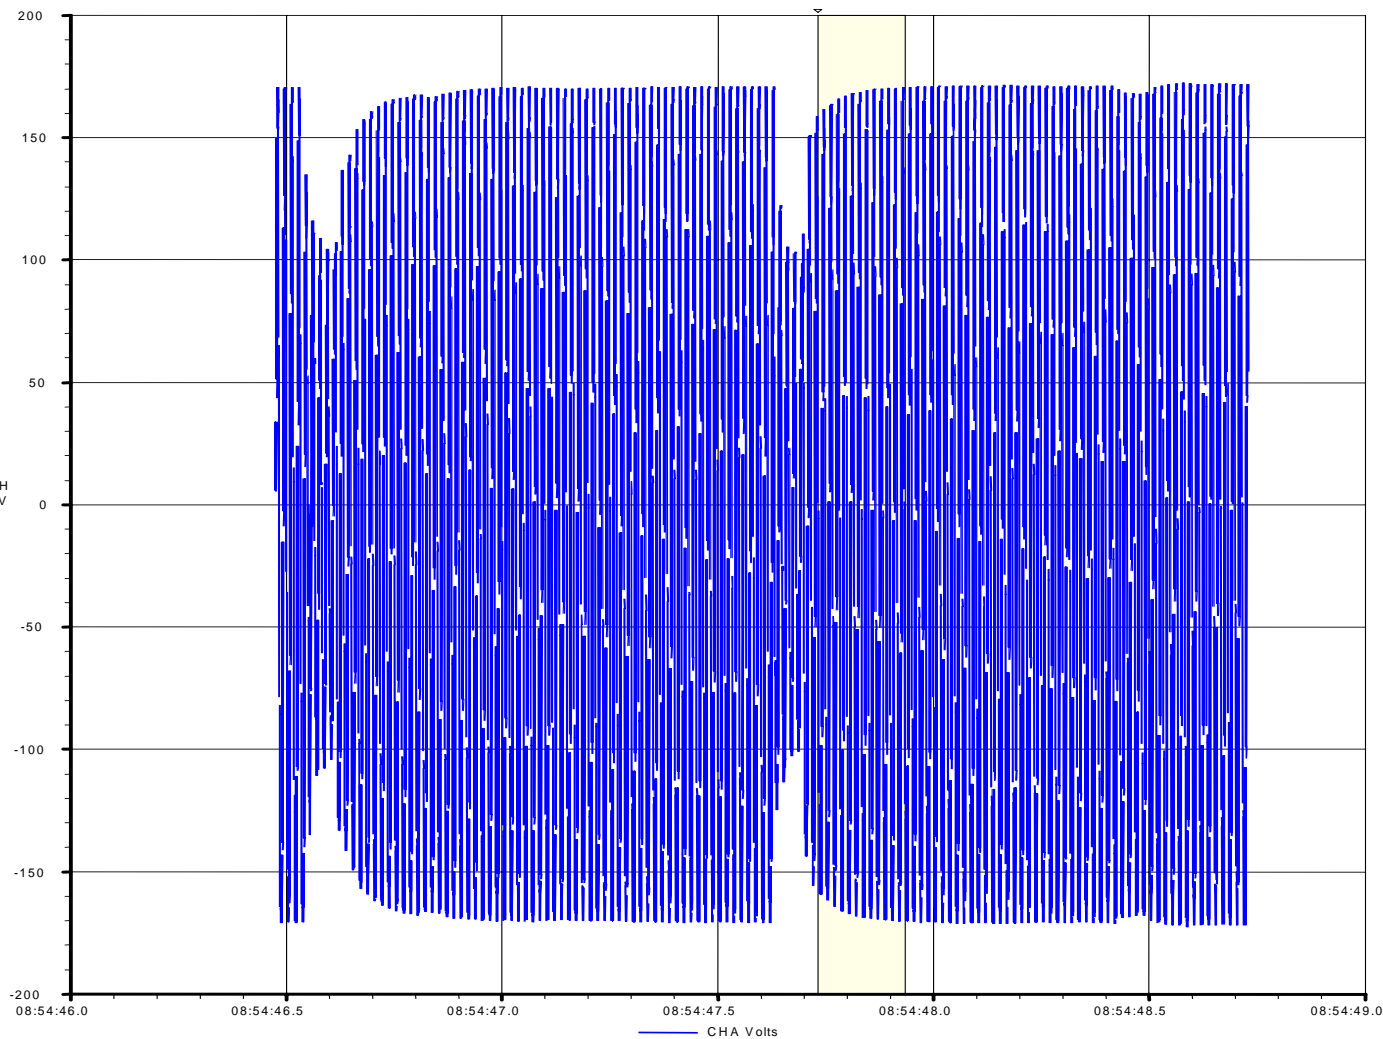
911B room

35 % dip
10 cycles

Waveforms at 05/29/2006 08:54:47

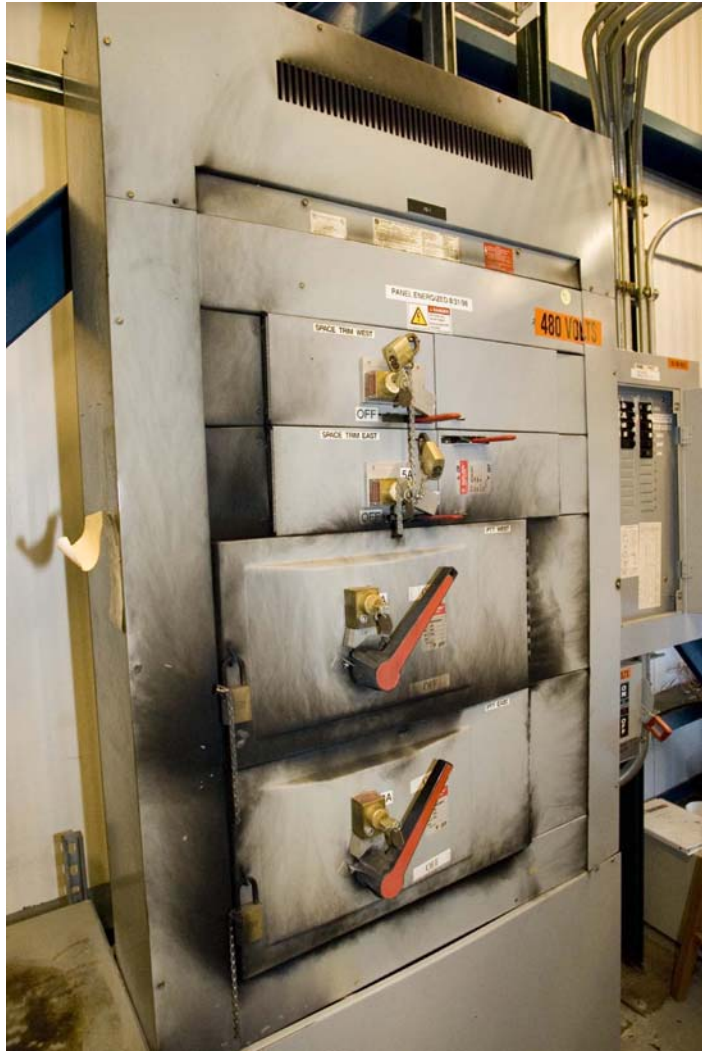
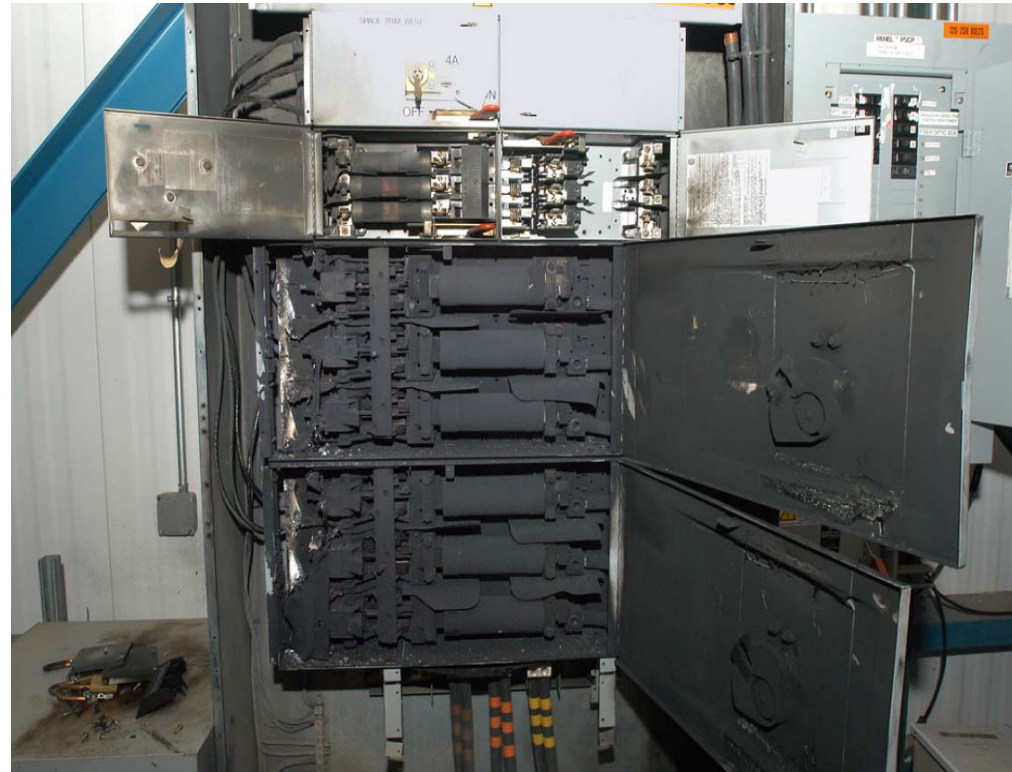
1006 Fuse Disconnect Switches Failure

Findings

- High transient voltage
 - Arcing ground fault on ungrounded delta system
- Foreign object
 - Open conduit stub may be source of foreign object
- Switch Failure (after examination of switches)

- Activate/install ground fault detection systems
- Install systems to minimize voltage transients
- Implement a project plan for energy calculations
- Review other practices:
 - Racking circuit breakers with bus energized
 - Inserting/removing motor control center starter-buckets while energized
